ENVIRONMENTAL TEST REPORT

Report Reference No.: LR500171204T

Test item Description WORK LIGHT

Basic model name PIT MASTER 30

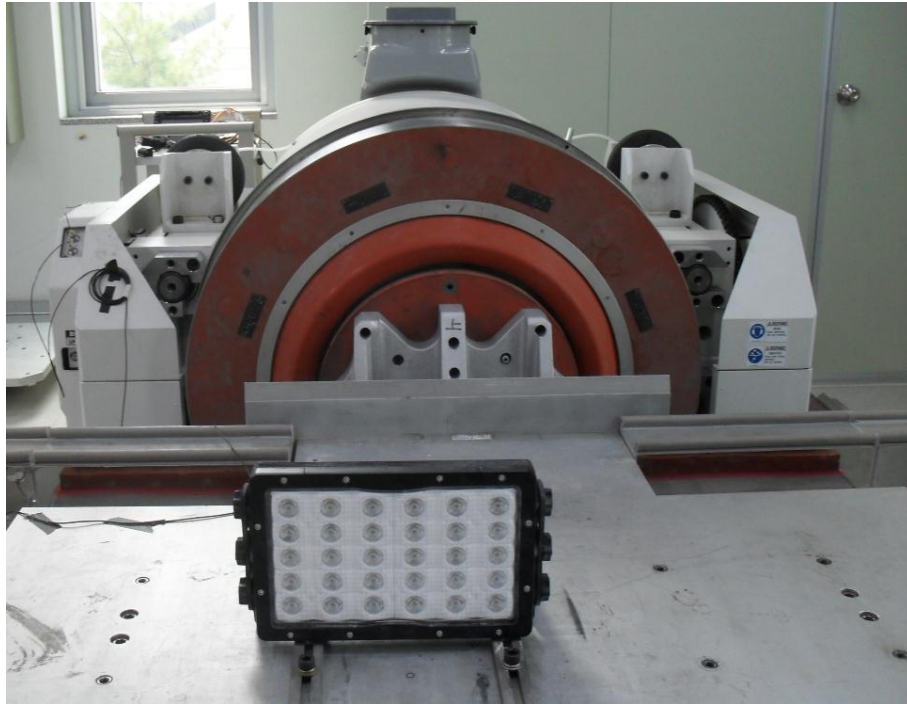
<Vibration & Shock Test Picture (Front and back: X Axis)>

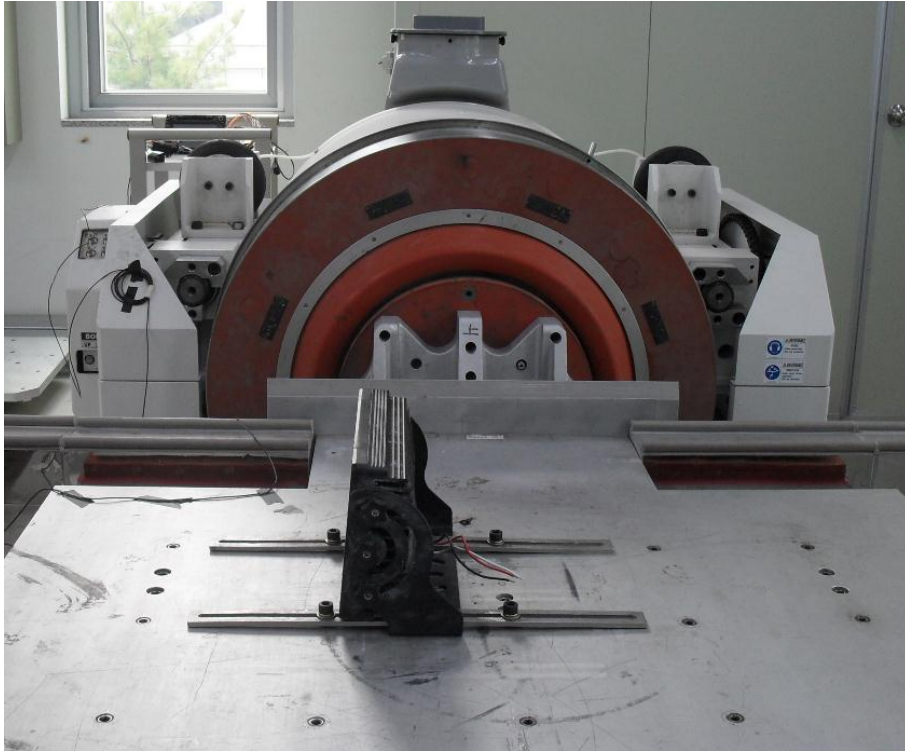
<Vibration & Shock Test Picture (Front and back: Y Axis)>

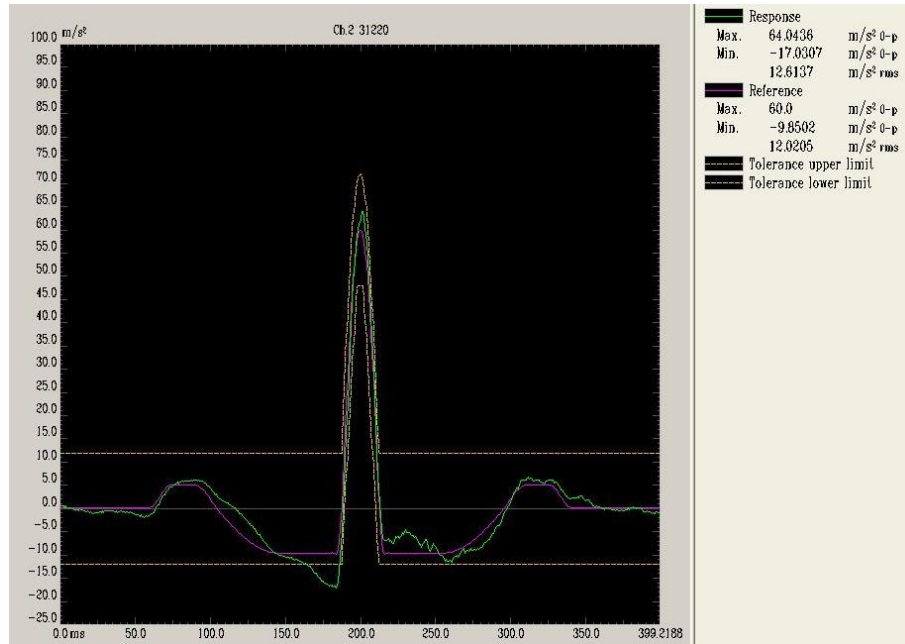
<Shock test data (Front and back: Y Axis(+))>

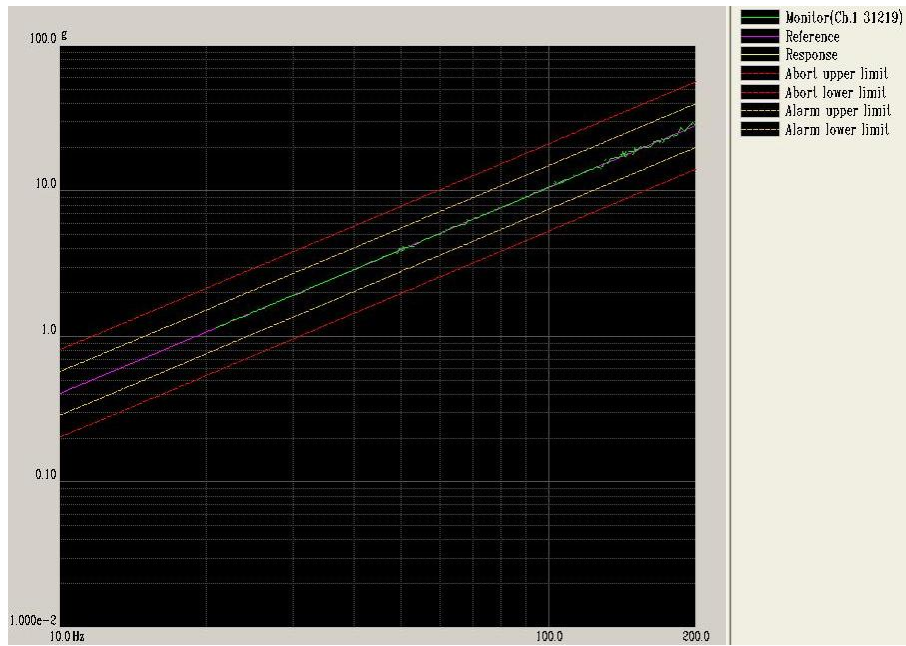
<Vibration test data (Front and back: Z Axis)>

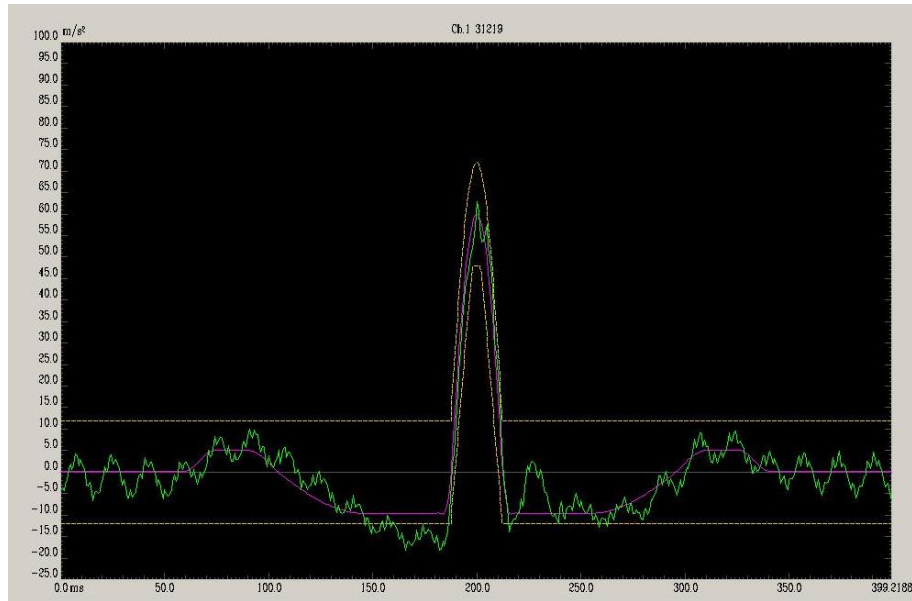
<Shock test data (Front and back: Z Axis(+))>

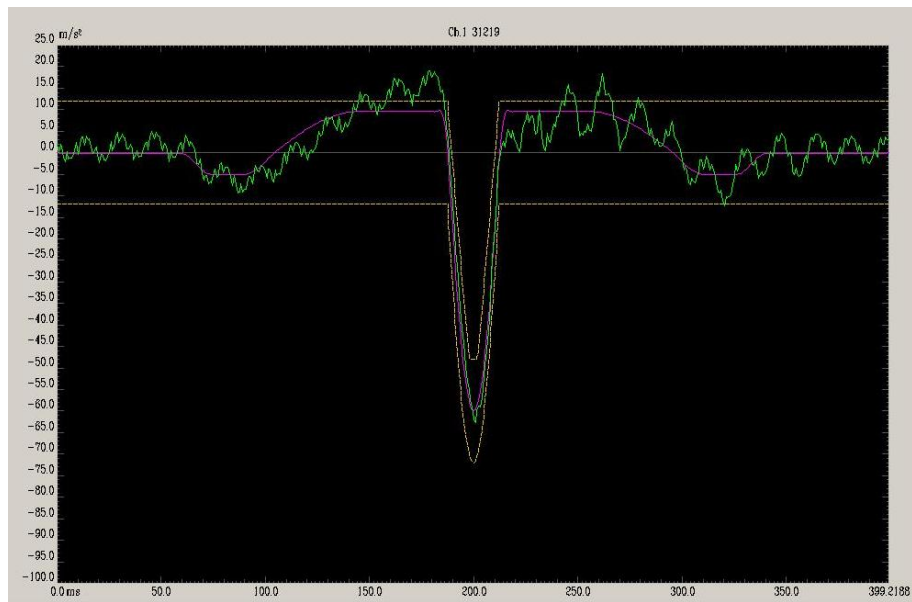
<Shock test data (Front and back: Z Axis(-))>

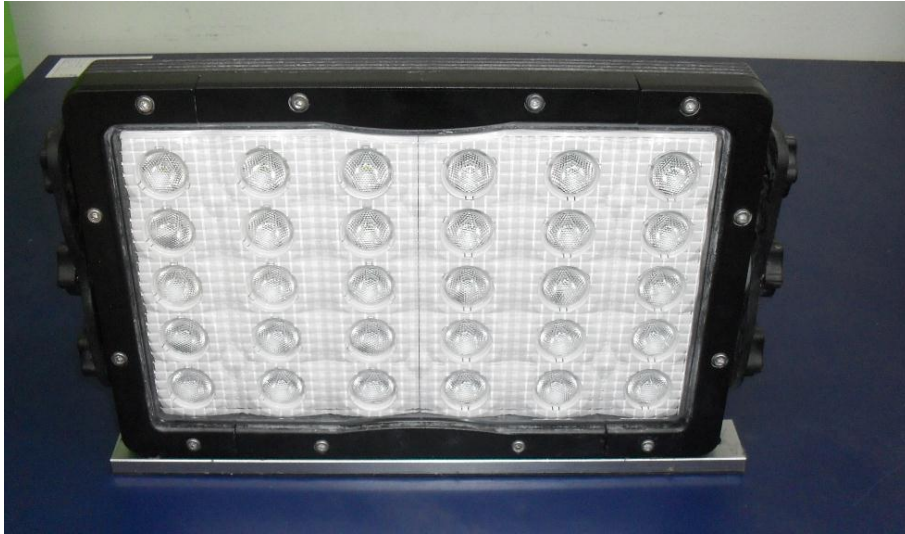
<Test sample>

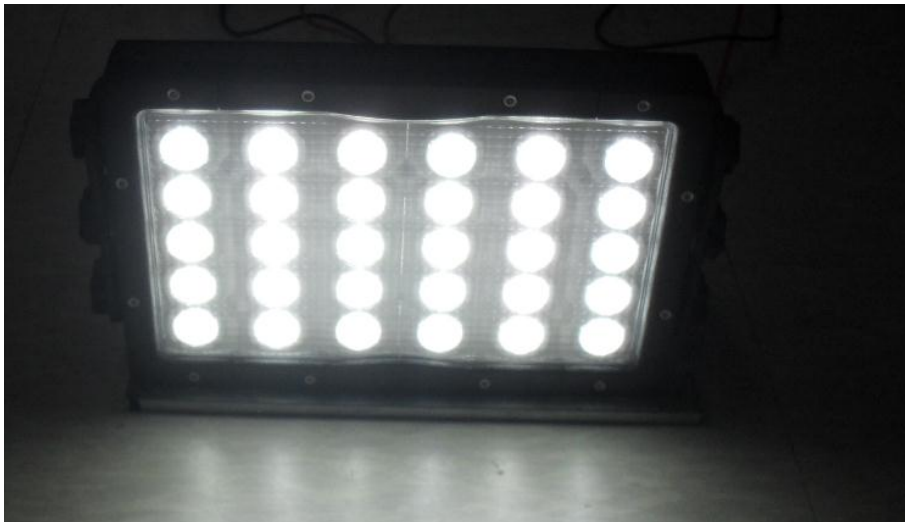
<Operating picture after the test>
